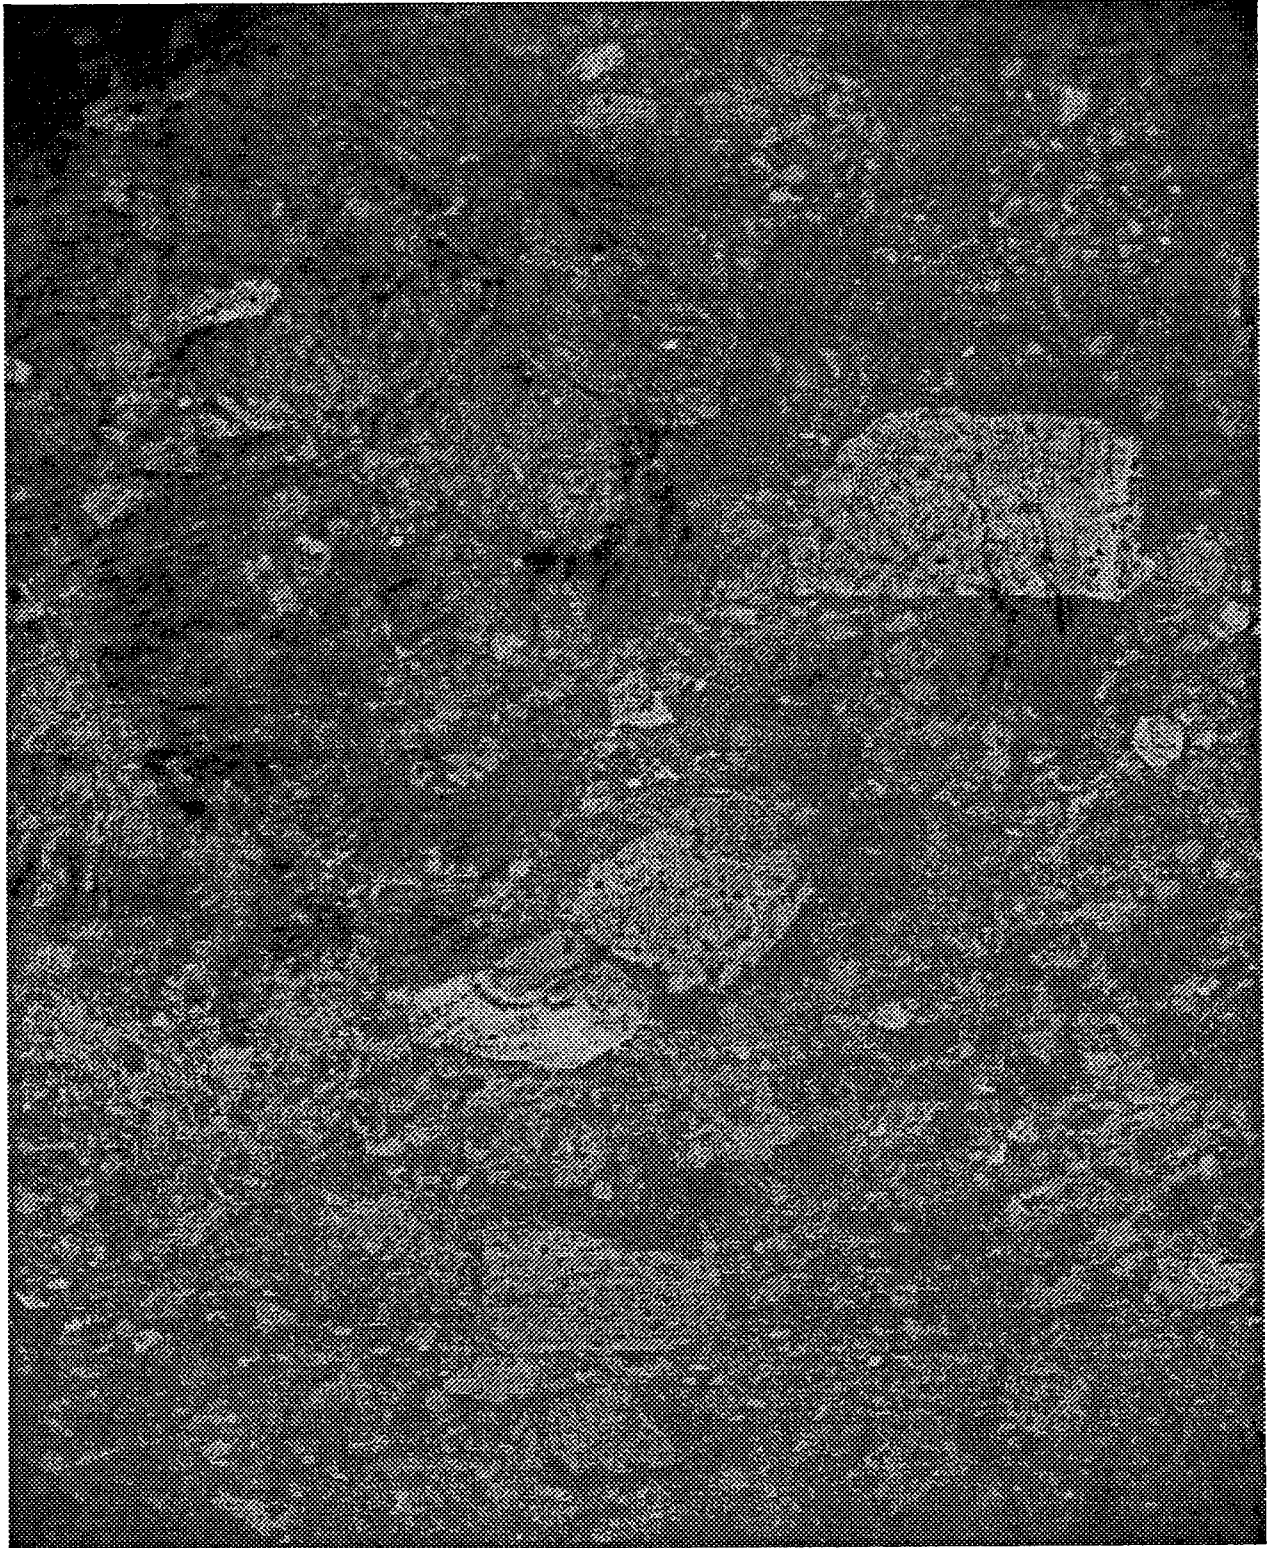
Photo D10 [3/4/98-3:15]

Into Cave Creek- looking at *Elimnia* snails- Site 32 (7)/99(7) - SE direction [CERFA Parcel Map 21, 39] This photo was taken on the opposite bank of Cave Creek from previous photo. The photo shows a large snail population (*Elimnia*) along the creek and under a bridge. Minnows (~2 in. long) noted under the bridge also.

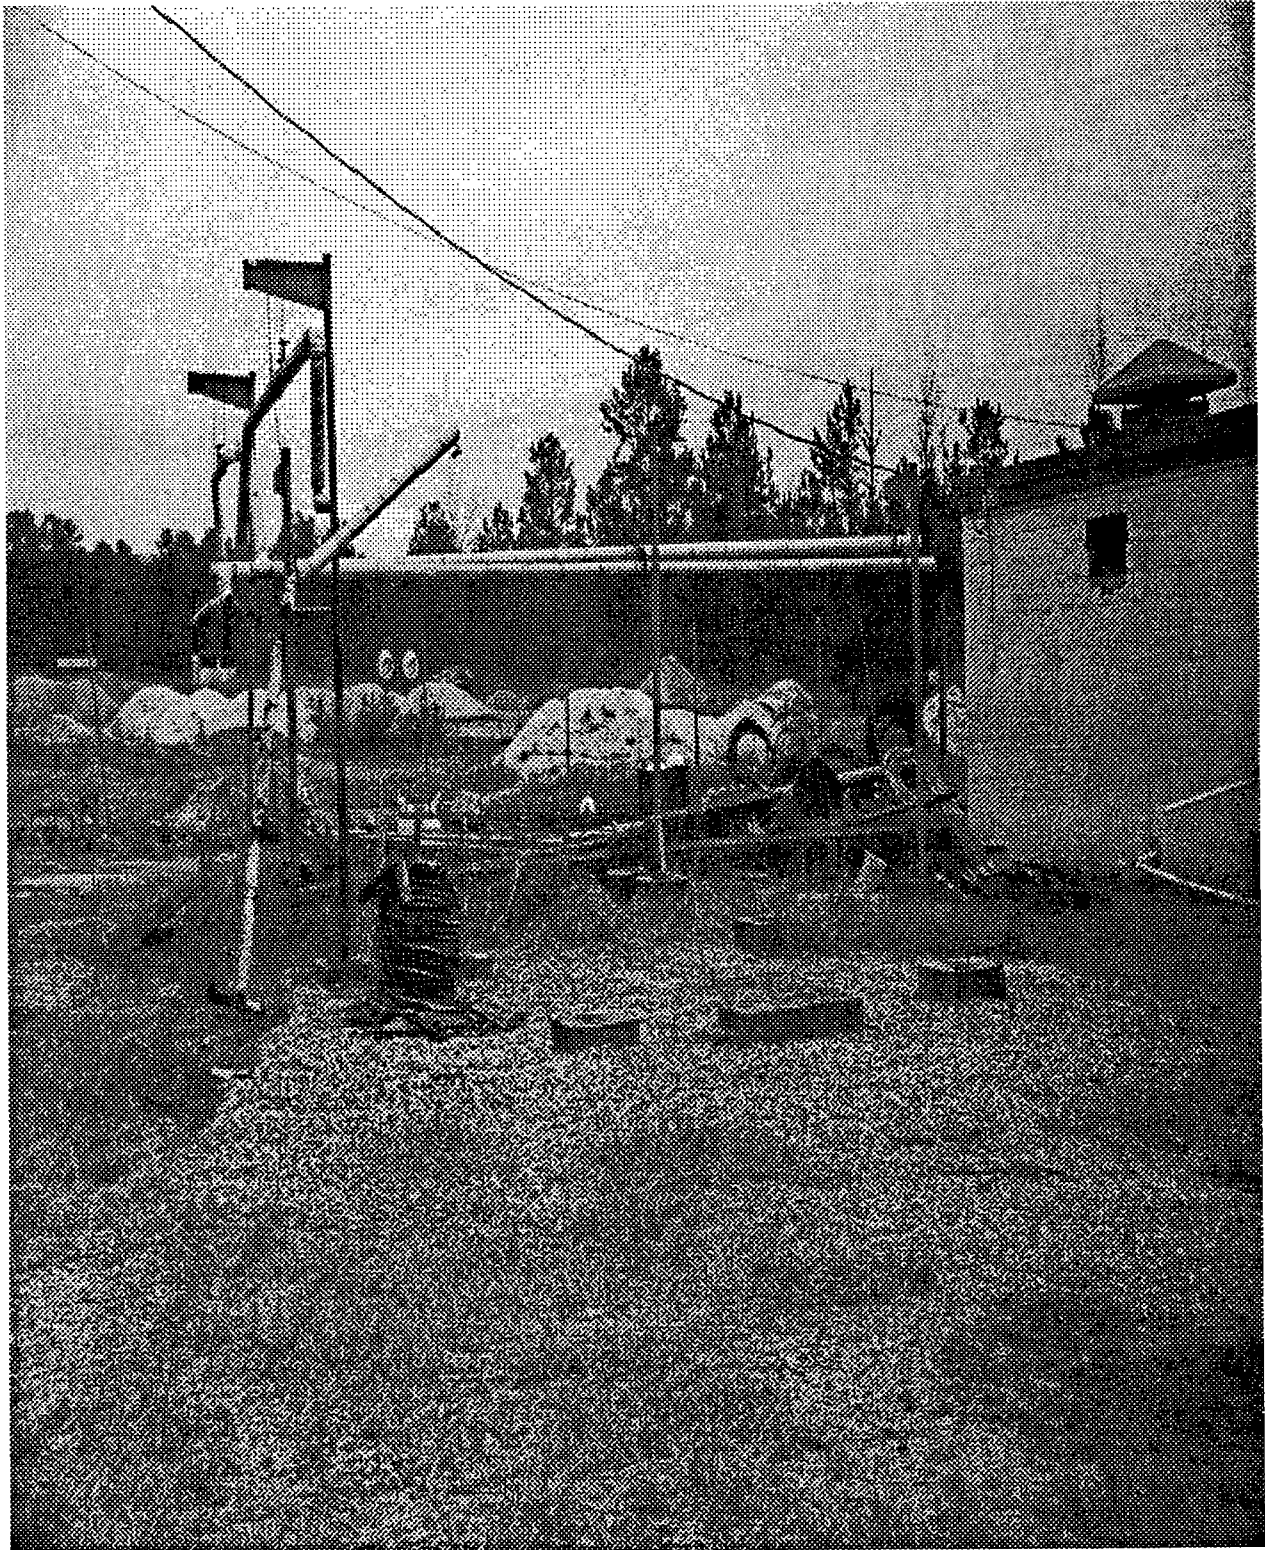
Photo D11 [3/4/98-3:20]

Former Tar Plant /Temporary Transformer Storage Bldg. (4437) Sites 32(7)/99(7) [CERFA Parcel Map 21,39] This photo taken in a NE direction shows the area behind bldg. 4437. Specifically it shows the tar above ground storage tank anchors inside the fence line of the transformer yard area.

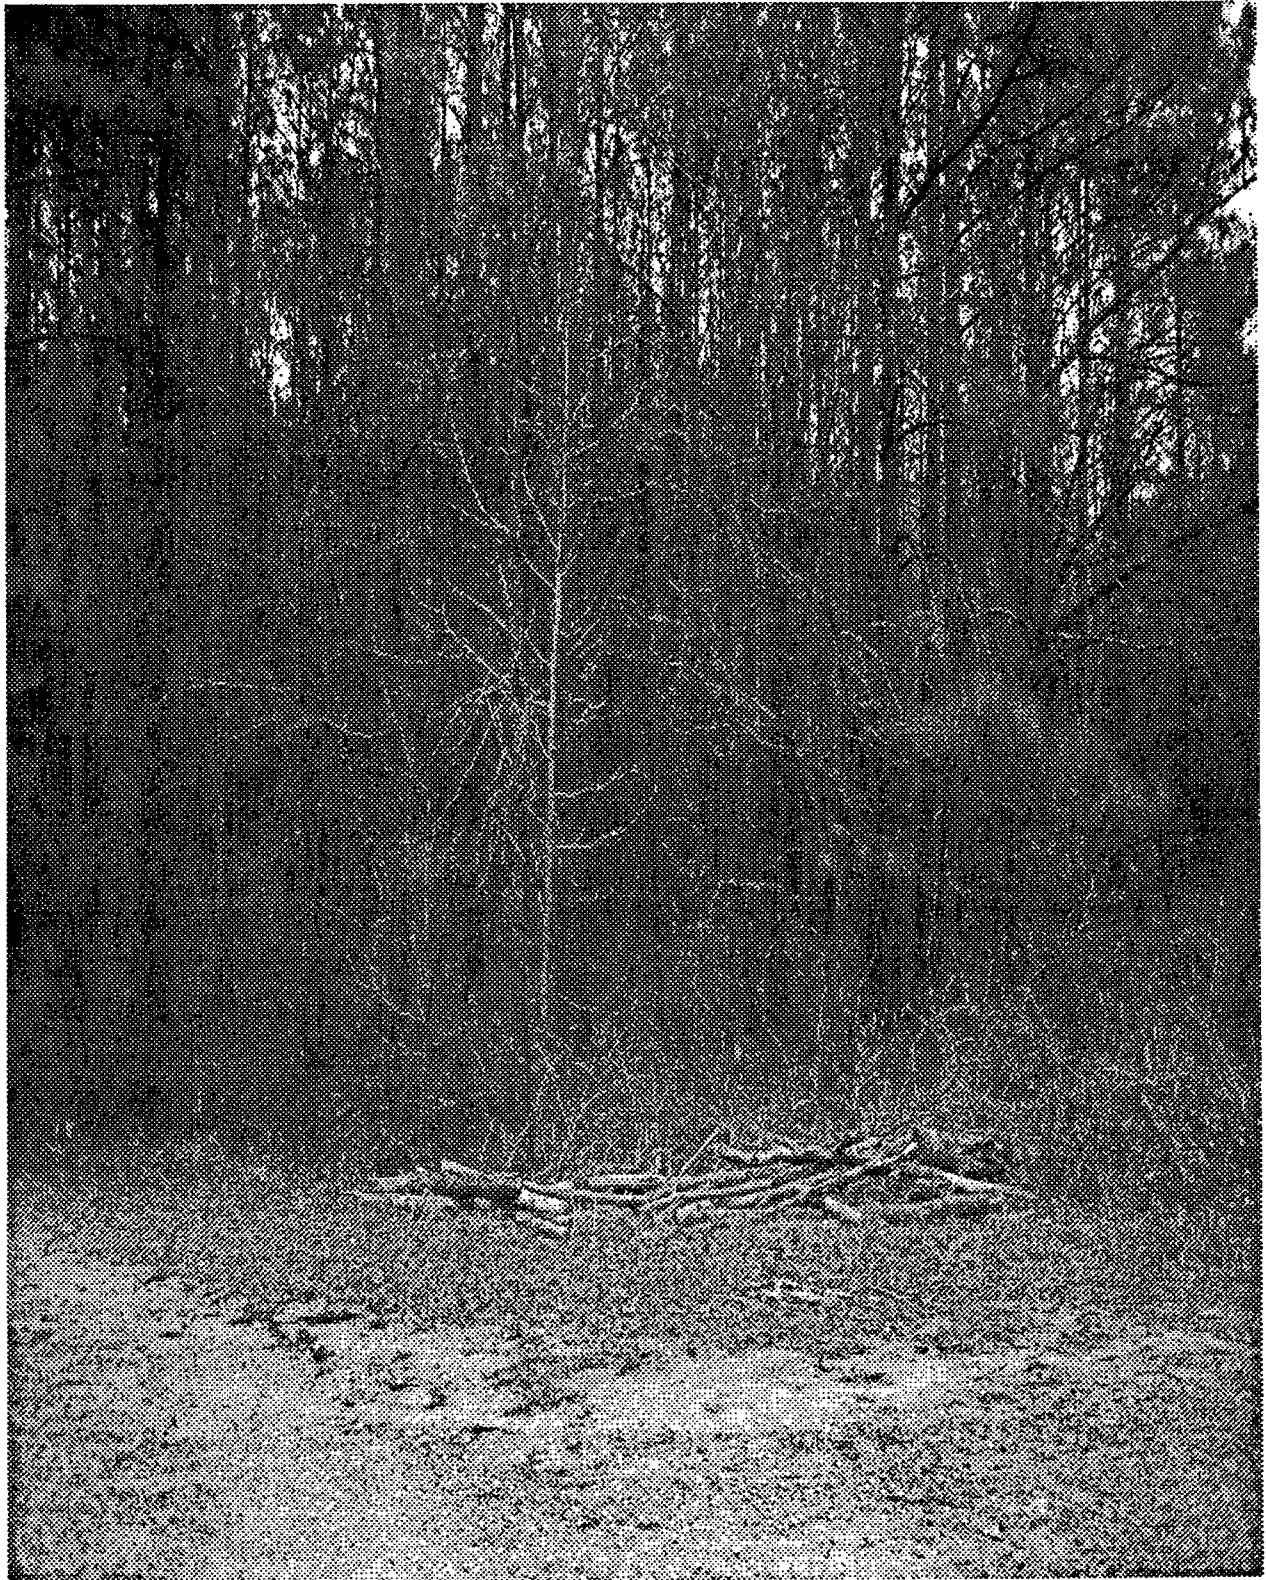
Photo D12 [3/4/98-3:25]

Potential dump/groundscar- Site 156(7) [CERFA Parcel Map 23,37] This photo shows a heavily wooded area (stand of pines) with a thick understory. No stream or creek areas were noted during site visit. Photo taken in a NE direction.

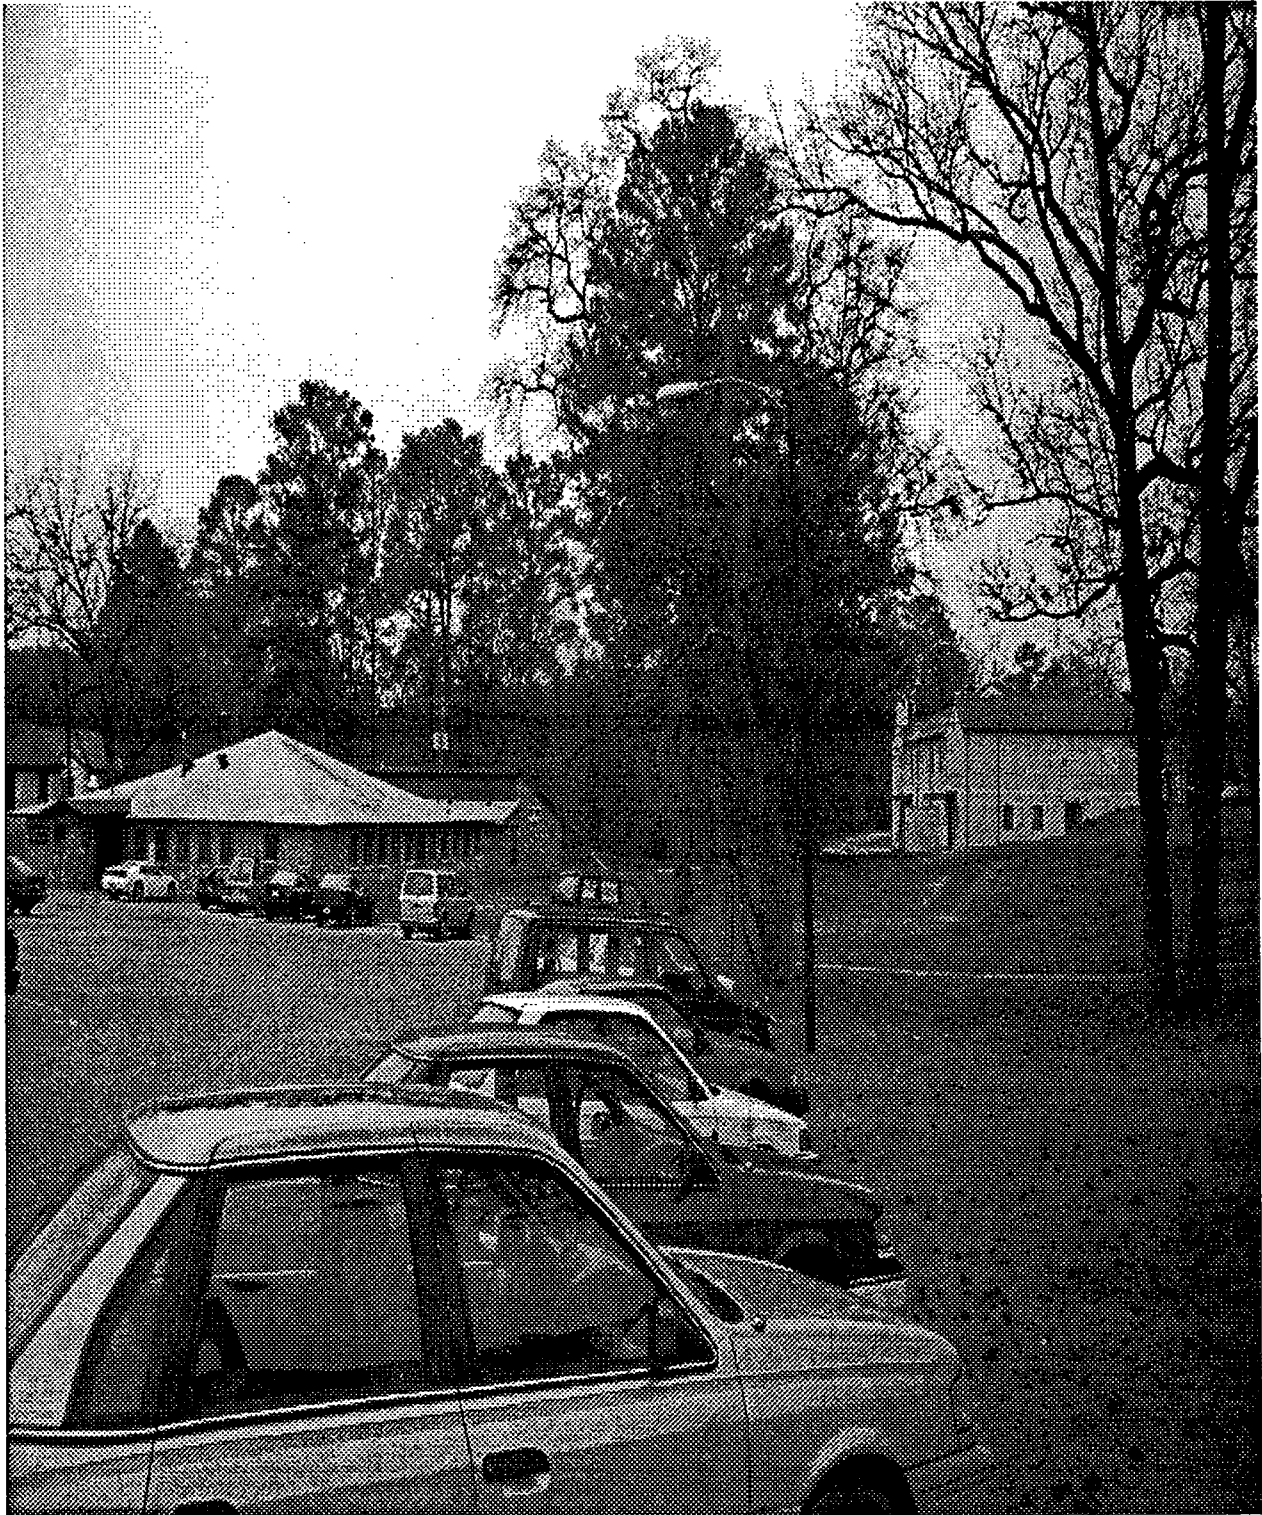
Photo D13 [3/4/98-3:35]

Sites 138(7) and 171(7) Former Printing Plant (bldgs. 143, 144) [CERFA Parcel Map 15, 33]

This site is located across the street from the Directorate of the Environment Bldg.. The site within a developed area with maintained lawns and parking lots. There are stands of trees around the perimeter of the lot. The area does not appear to be a good habitat.

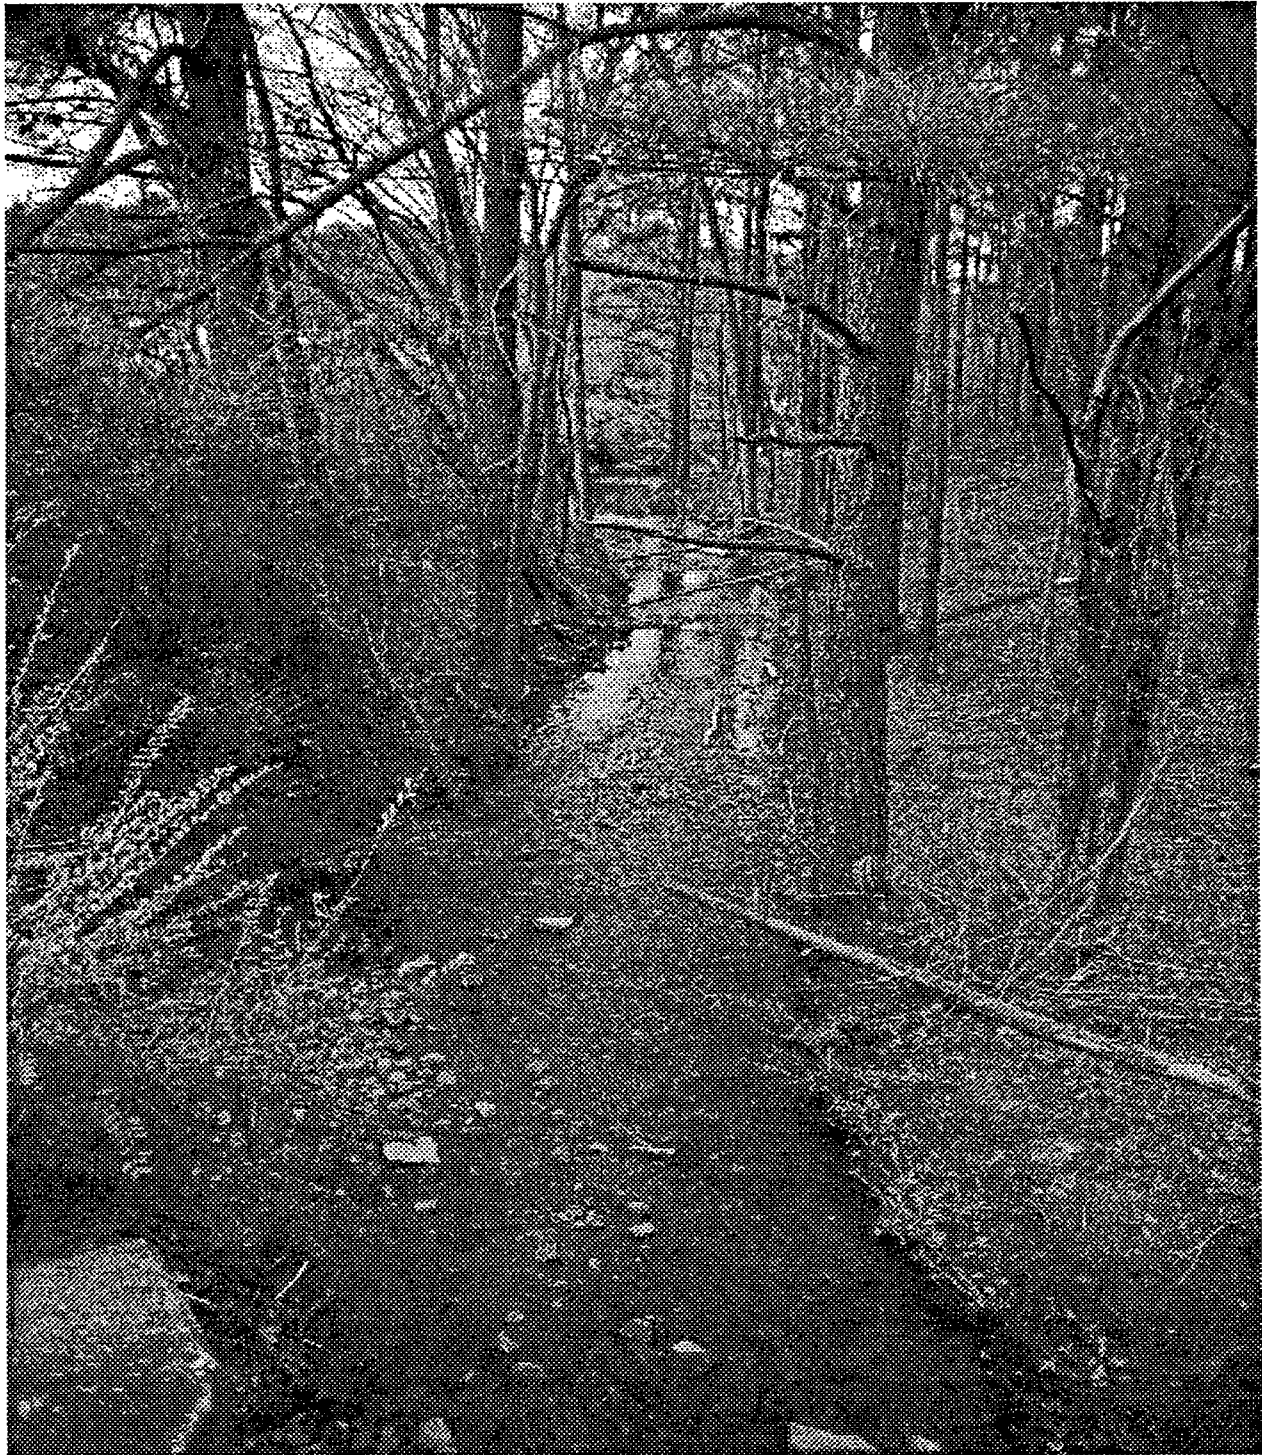
Photo D14 [3/4/98-4:20]

11th Chemical Motor Pool; Sites 29(7), 30(7), and 74(7) [CERFA Parcel Map 13, 31]

The site is currently a large developed area consisting of three large buildings, several small buildings, at least one wash rack, and a large parking area with parked military vehicles. This photo was taken from bridge No. 4353 (~15 yds. east of site) shooting NNW downstream along Remount Creek. This creek runs parallel with the eastern fence line of the motor pool. A small pine tree canopy follows the length of the creek and shrub/scrub vegetation is present. The stream bed is very rocky. Frogs, and minnows were seen in stream. Beaver activity was noticed along creek bank.

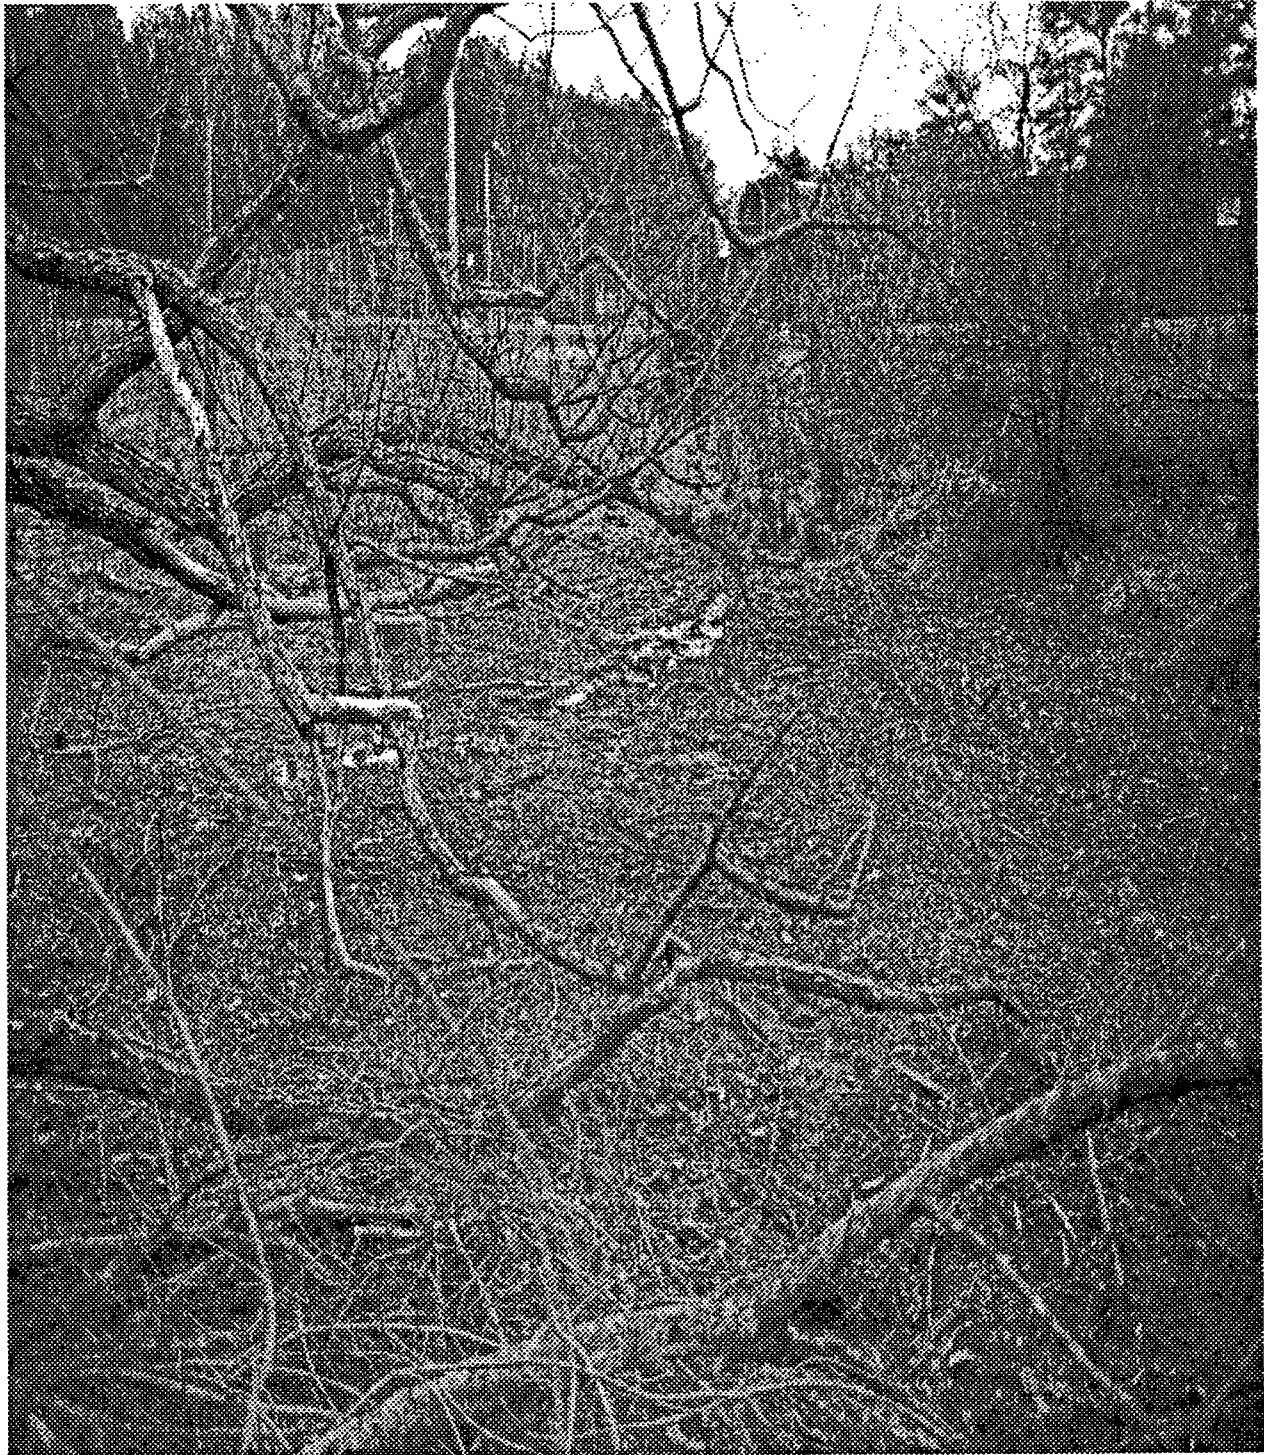
Photo D15 [3/4/98-4:25]

This photograph (shot to the south) depicts a drainage area from the 11th Chemical Motor Pool. The fence line can be seen in the distance. On the other side of the fence line a parking area with military vehicles can be seen. The drainage pathway is approximately 40-60 yds. from the fence line to the creek.

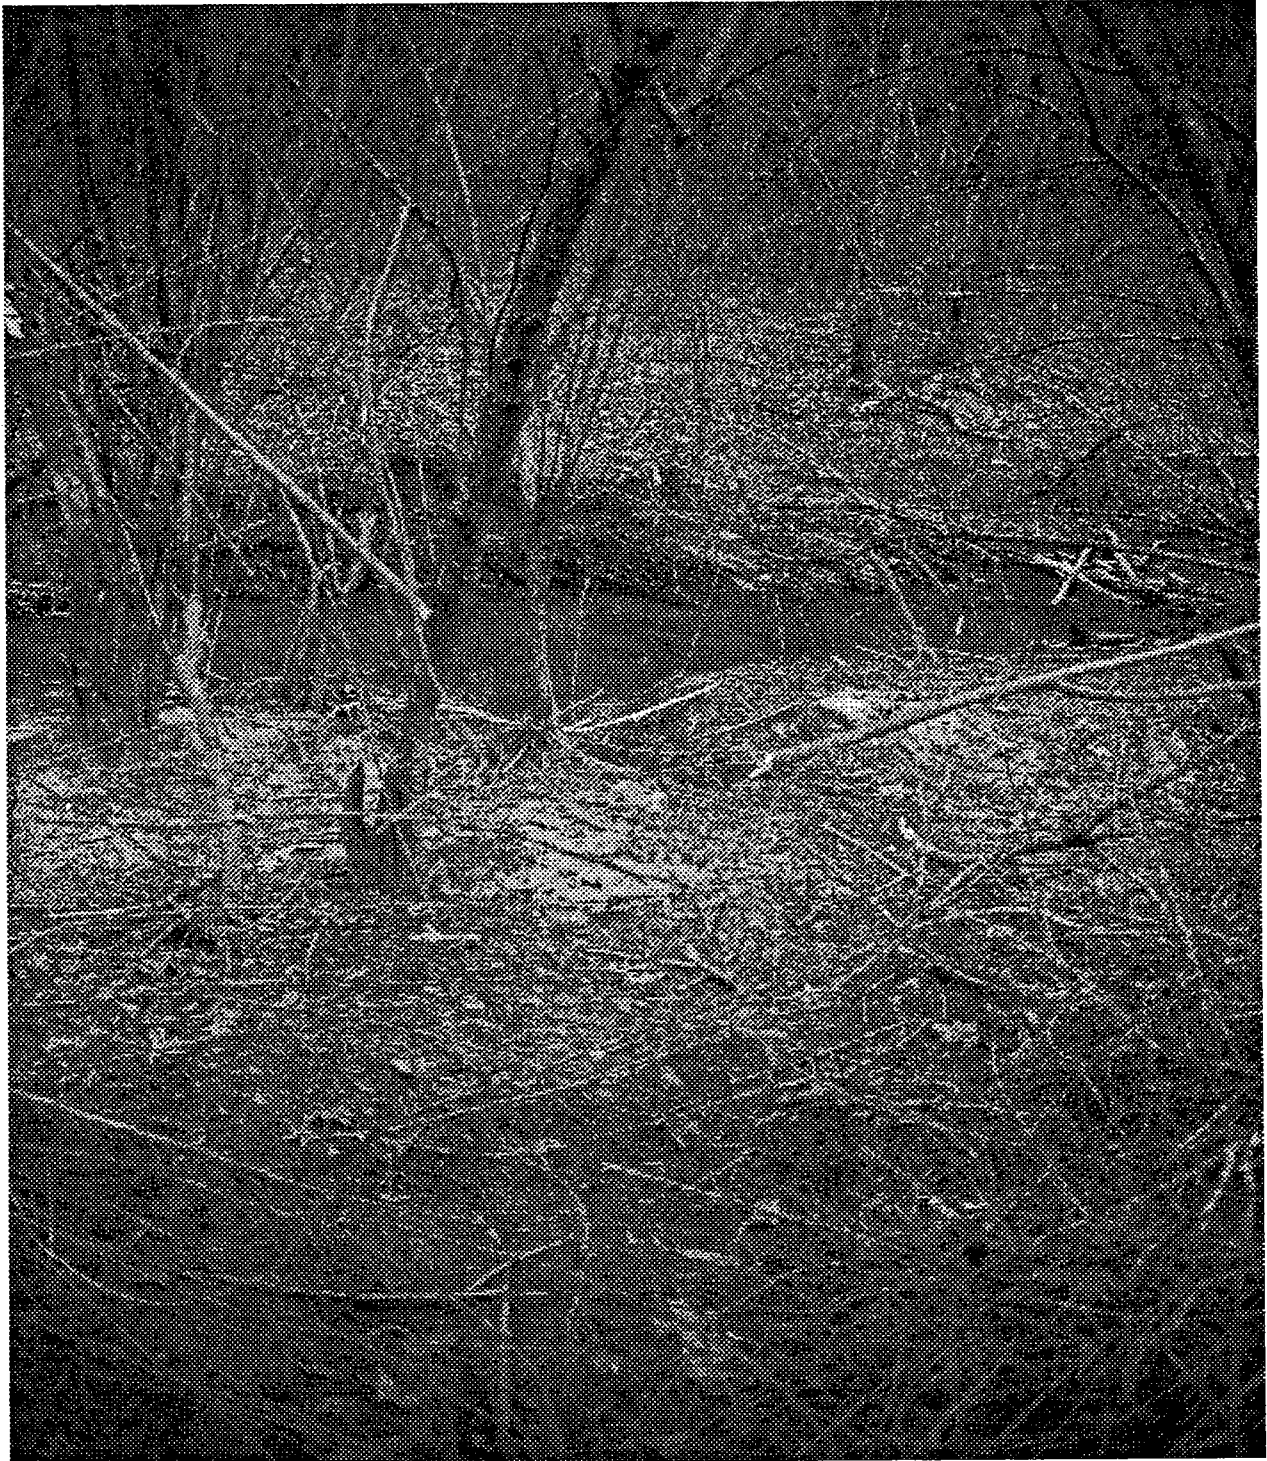
Photo D16 [3/4/98-4:25]

This photograph (shot to the east) depicts the outfall of the drainage pathway described in photo D15. There is evidence of beaver activity in this general area (i.e., chewed trees, dam, etc.). Deer tracks were also noted all along the pathway by the stream.

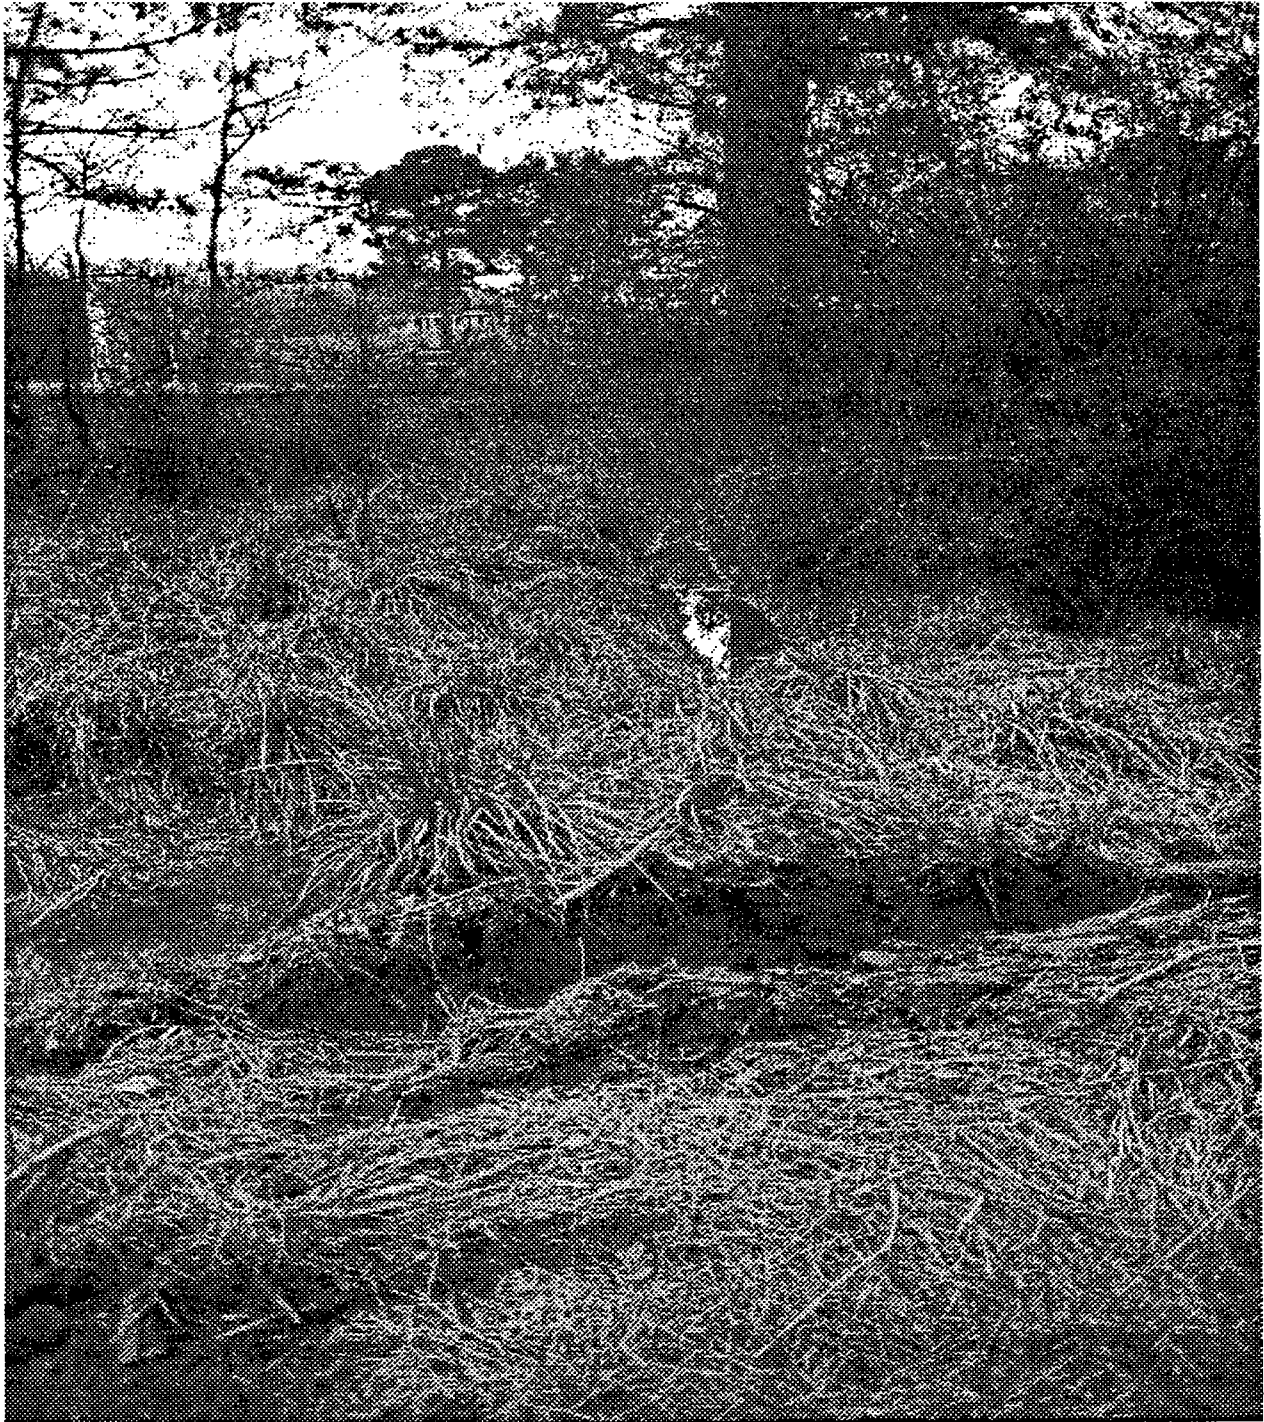
Photo D17 [3/4/98-4:28]

The site is currently a large developed area consisting of three large buildings, several small buildings, at least one wash rack, and a large parking area with parked military vehicles. This photograph (shot to the west) depicts a second drainage area to Remount Creek. There are big ruts in the ground in this general area. The ruts seem to be made by large heavy vehicles. This drainage pathway seem to drain from the NE corner of the fence line. It appears to drain the entire motor pool area, including washrack. The drainage pathway discharges directly into the creek. This area is covered by large tufts of grasses, and shrub/scrub vegetation.

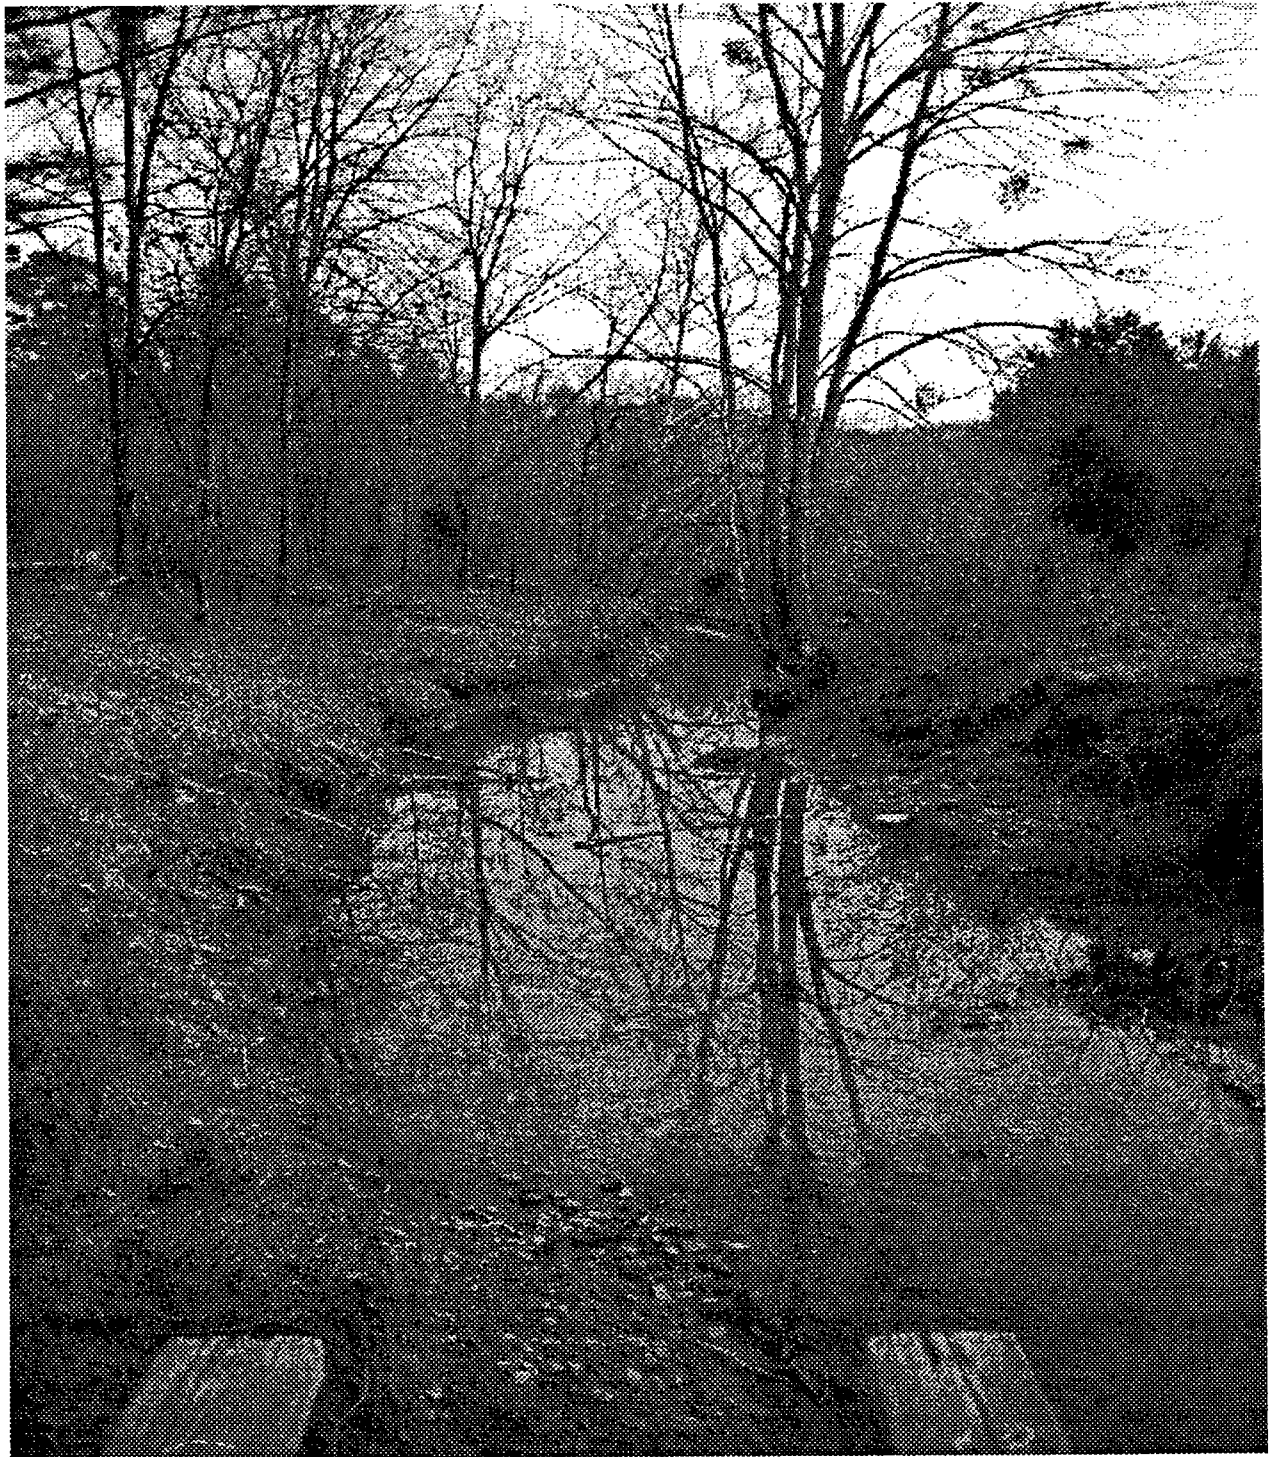
Photo D18 [3/4/98-4:42]

This photograph (shot to the south), was taken past the end of the fence line looking upstream into Remount Creek, while standing on a railroad tie foot bridge. The stream is approximately 5-6 feet wide. A second beaver dam was spotted approximately 30 yds. upstream of the foot bridge.

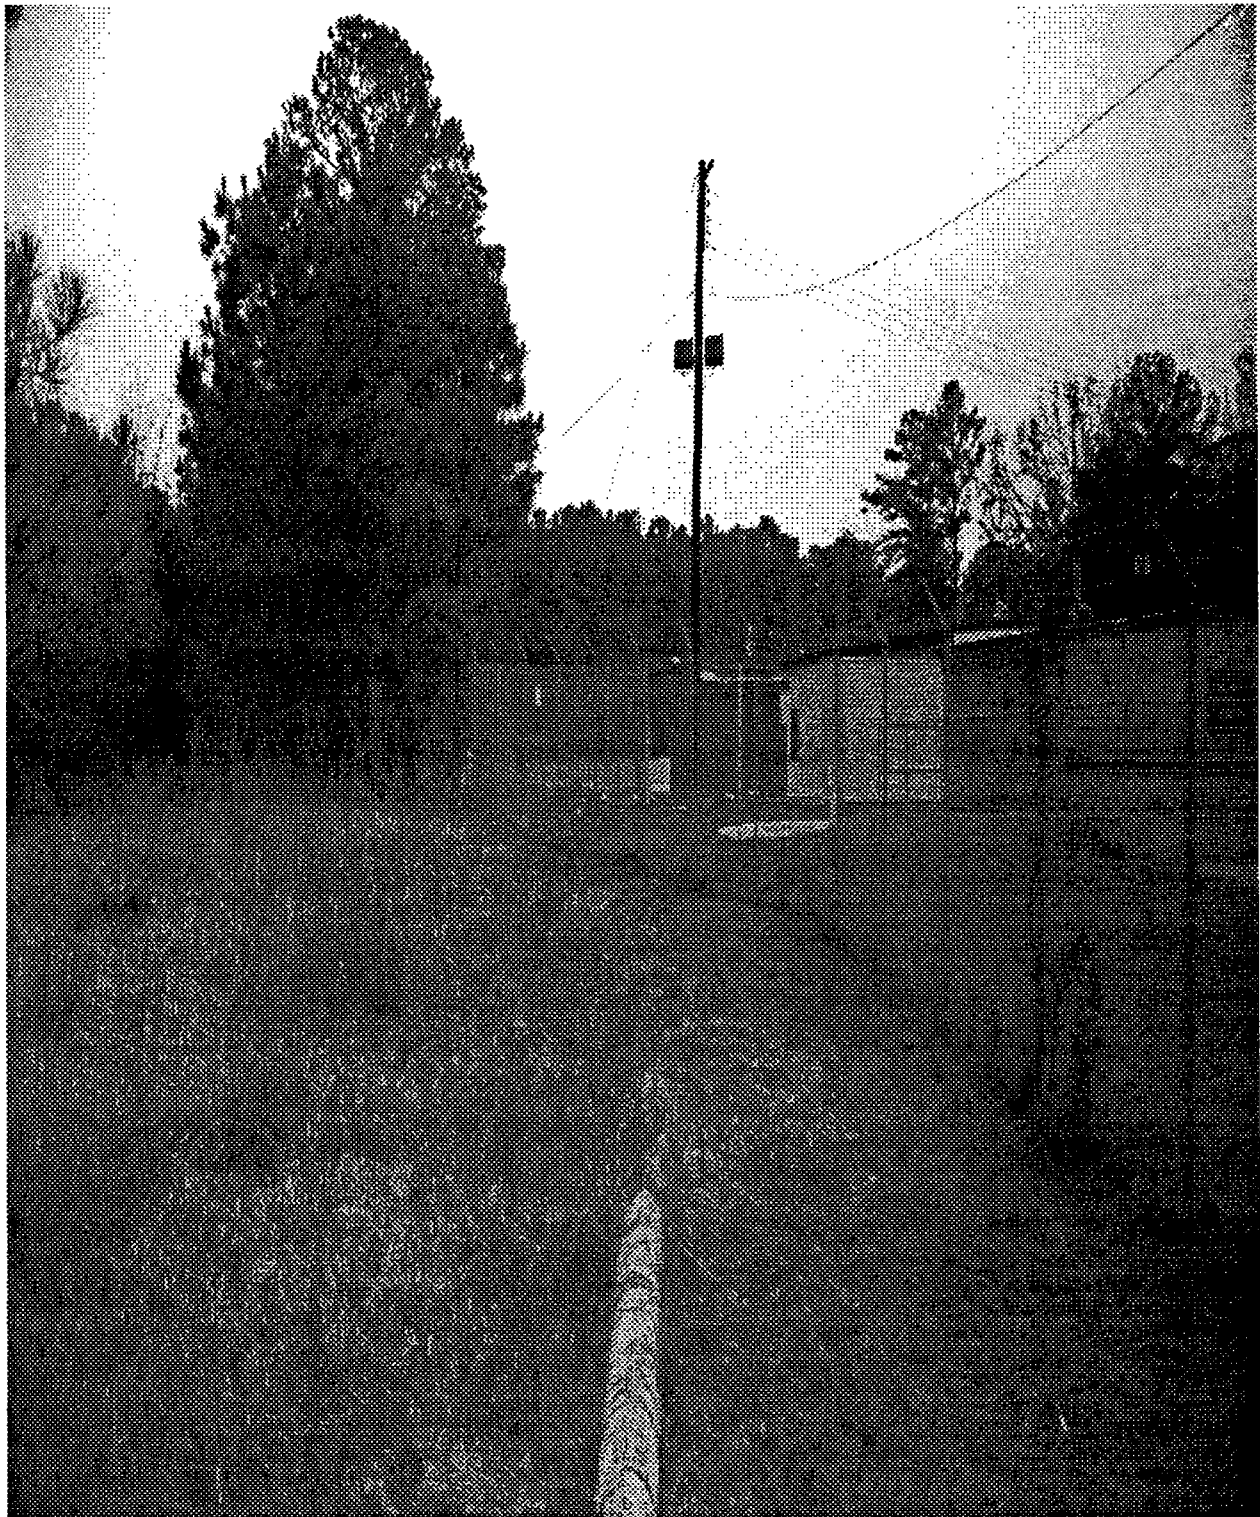
Photo D19 [3/4/98-4:42]

The site is currently a large developed area consisting of three large buildings, several small buildings, at least one wash rack, and a large parking area with parked military vehicles. This photograph (shot to the S) depicts the eastern fence of the 11th Chemical Motor Pool, adjacent to a vegetated strip of land separating the site from Remount Creek.

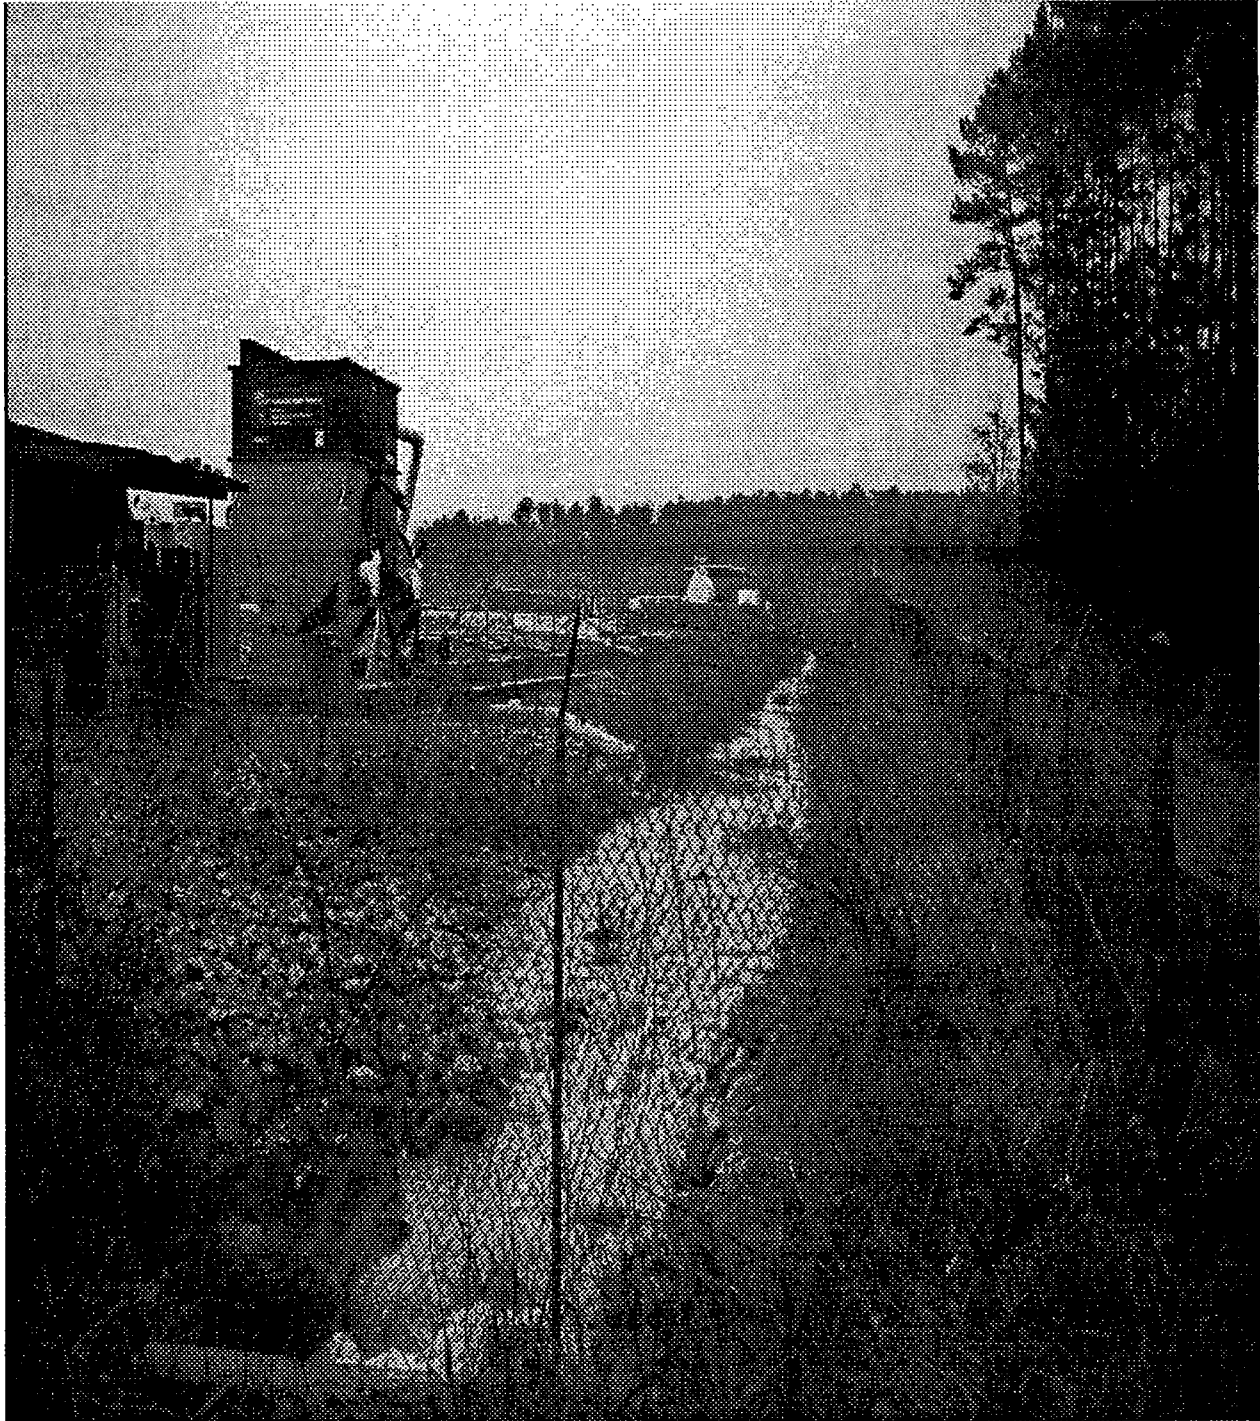
Photo D20 [3/5/98-9:45]

Pelham Range Wash Racks ; UTES No. 1 Site 103(3) [CERFA Parcel Map 56,32]

This photograph (shot to the E) is looking at drainage ditch at the SE boundary fence. AST, maintenance area and military vehicles in background. The photo also shows high storm water flow through drainage ditch at the site. The wash rack is to the right and the AST and vehicle parking is in the background. The area consists mainly of wide open paved area surrounded by pine forest. The wash rack at this site contains 16 wash points within the same facility. These washracks are connected to one sedimentation basin which is equipped with a float block and an oil skimmer. The discharge water from this system flows into a tributary of Cane Creek.
